ANNUAL REPORT FOR 2010

**Mile Branch
Guilford County
TIP No. R-0609IA**

Prepared By:
Natural Environment Unit & Roadside Environmental Unit
North Carolina Department of Transportation
October 2010

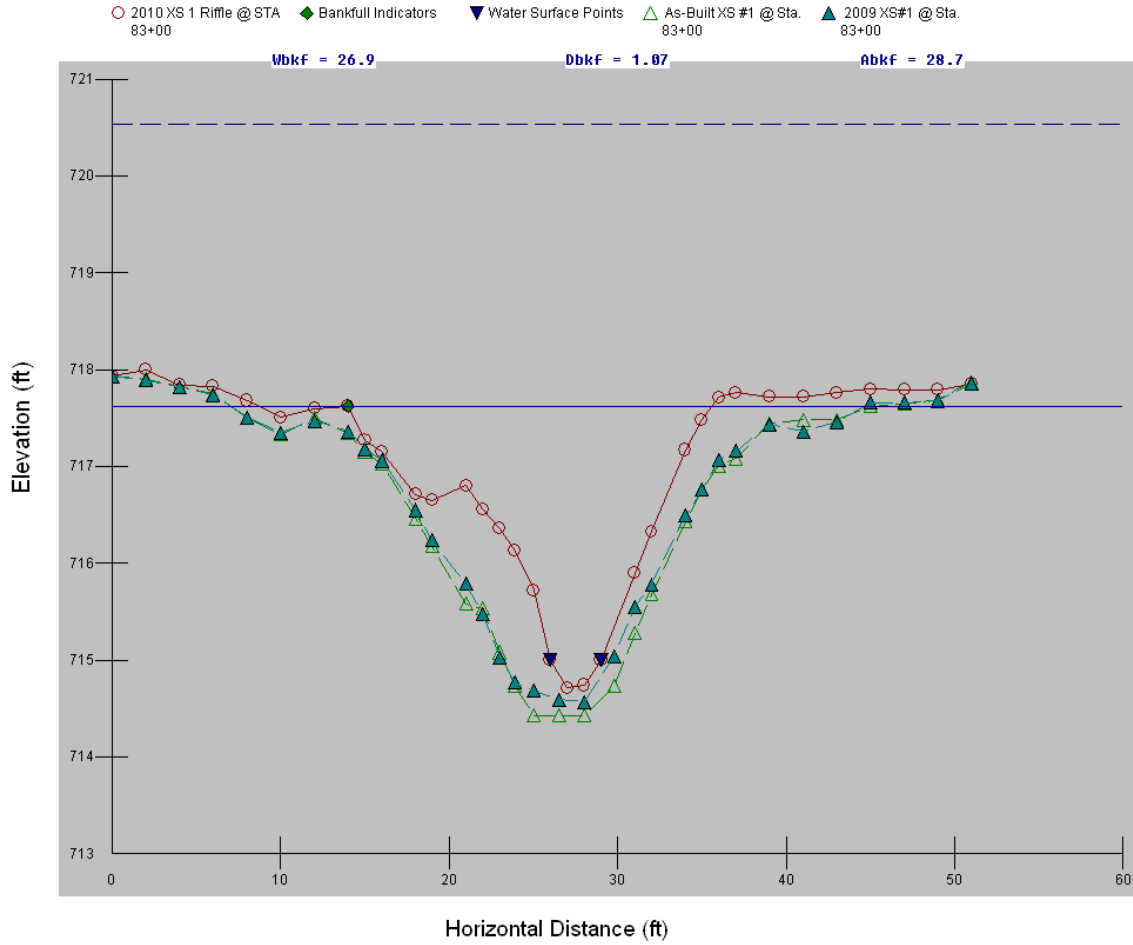
Riffle Cross Section #1 @ STA 83+00

Cross-Section #1 (Riffle) Abbreviated Morphological Summary					
	2009	2010	2011	2012	2013
Bankfull Width (ft)	26.3	26.9			
Bankfull Mean Depth (ft)	1.4	1.06			
Width/Depth Ratio	18.8	25.38			
Bankfull Cross Sectional Area (ft ²)	36.9	28.64			
Maximum Bankfull Depth (ft)	2.86	2.91			
Width of the Floodprone Area (ft)	51	51			
Entrenchment Ratio	1.94	1.9

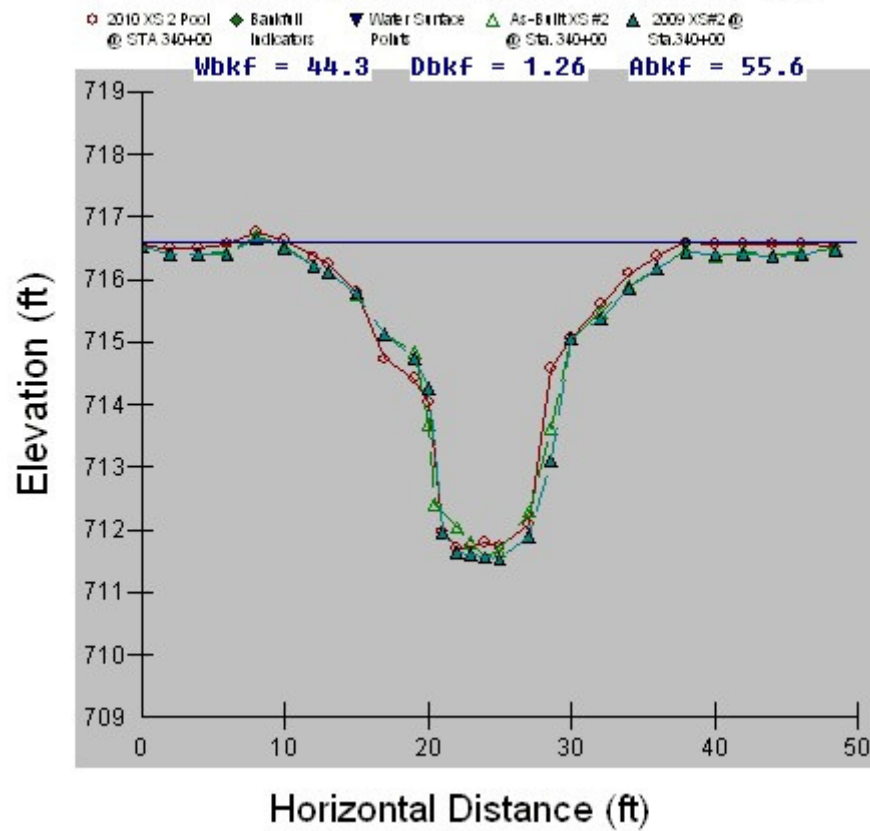
Pool Cross Section #2 @ STA 340+00

Cross-Section #2 (Pool) Abbreviated Morphological Summary*					
	2009	2010	2011	2012	2013
Bankfull Cross Sectional Area (ft ²)	55	55.65			
Maximum Bankfull Depth (ft)	4.89	4.89			
Bankfull Mean Depth (ft)	2	1.26			
Bankfull Width (ft)	27.52	27.69

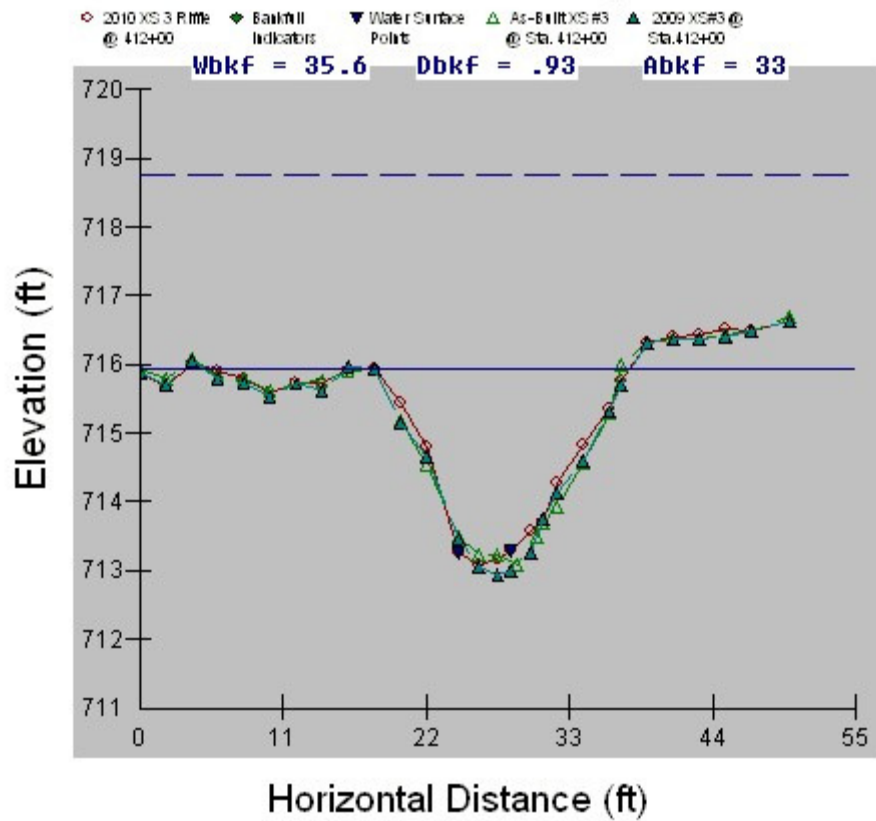
Riffle Cross Section #3 @ 412+00

Cross-Section #3 (Riffle) Abbreviated Morphological Summary					
	2009	2010	2011	2012	2013
Bankfull Width (ft)	19.75	19.61			
Bankfull Mean Depth (ft)	1.68	1.57			
Width/Depth Ratio	11.76	12.49			
Bankfull Cross Sectional Area (ft ²)	33.15	30.76			
Maximum Bankfull Depth (ft)	3	2.84			
Width of the Floodprone Area (ft)	49.9	49.9			
Entrenchment Ratio	2.53	2.54

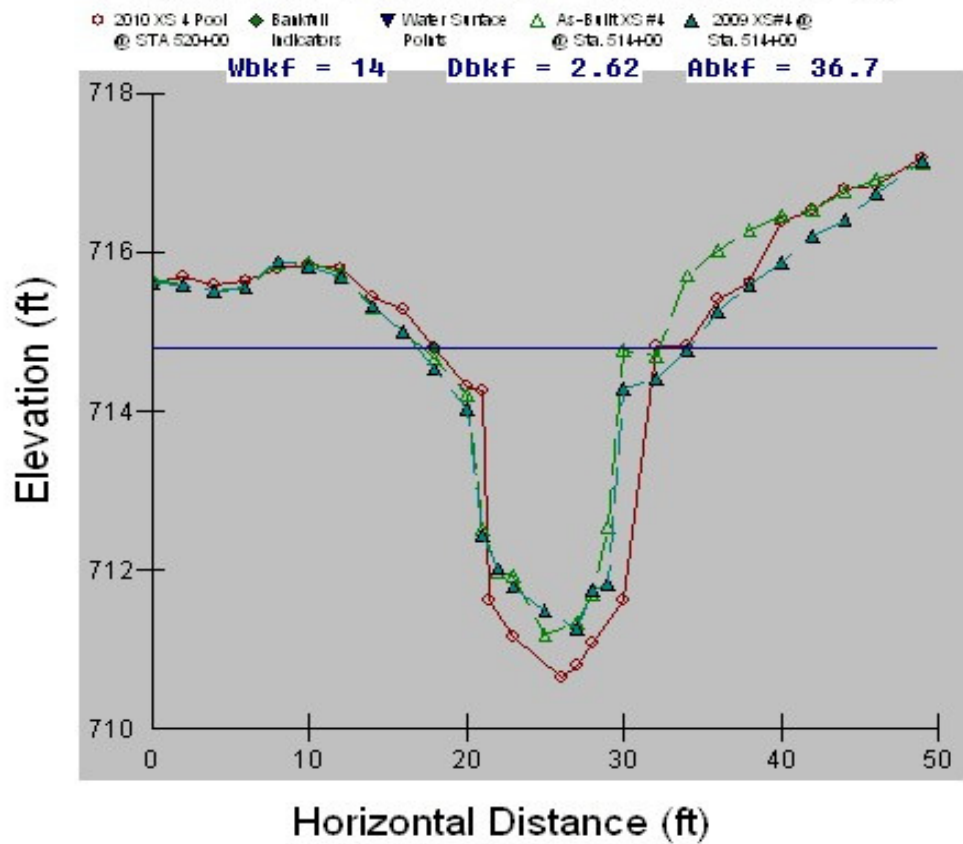
Pool Cross Section #4 @ STA 520+00

Based on comparisons of the monitoring data, all four cross sections appear stable with little or no active bank erosion. The floodplain on the right bank at Cross Section #4 had to be repaired after the as-built was completed and the right endpin at this cross section had to be reset for a second time. The graph of Cross Section #4 shows this layout. Graphs of the cross sections are presented in Appendix A. Future survey data will vary depending on actual location of rod placement and alignment; however this information should remain similar in appearance. The longitudinal profile shows that the channel is stable for the 2010 monitoring evaluation. An area of bank scouring on the right bank was noted at Photo Point #6. Debris and sediment was deposited onto the floodplain since the last evaluation which indicates that a bankfull event has occurred.

Cross-Section #4 (Pool) Abbreviated Morphological Summary*					
	2009	2010	2011	2012	2013
Bankfull Cross Sectional Area (ft ²)	23.18	36.71			
Maximum Bankfull Depth (ft)	3.02	4.15			
Bankfull Mean Depth (ft)	2.11	2.62			
Bankfull Width (ft)	11	14
